**City of Miami
Marine Stadium
At
Virginia Key**

Existing Building Condition Assessment

Project No.: F008449.00

July 21st, 2008

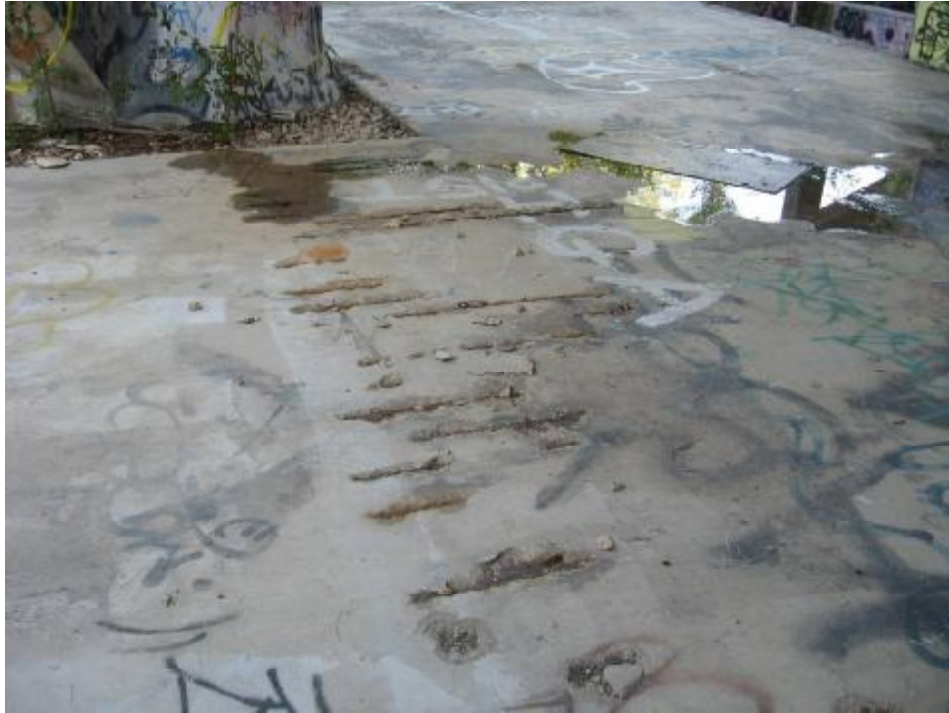
Photo 17

concrete and exposed corroded rebar (Photo 7, 8, 9, 10, 11, 12, 17). Each of the deteriorated areas requires repair to prevent further deterioration and to eliminate the many tripping hazards to the occupants.

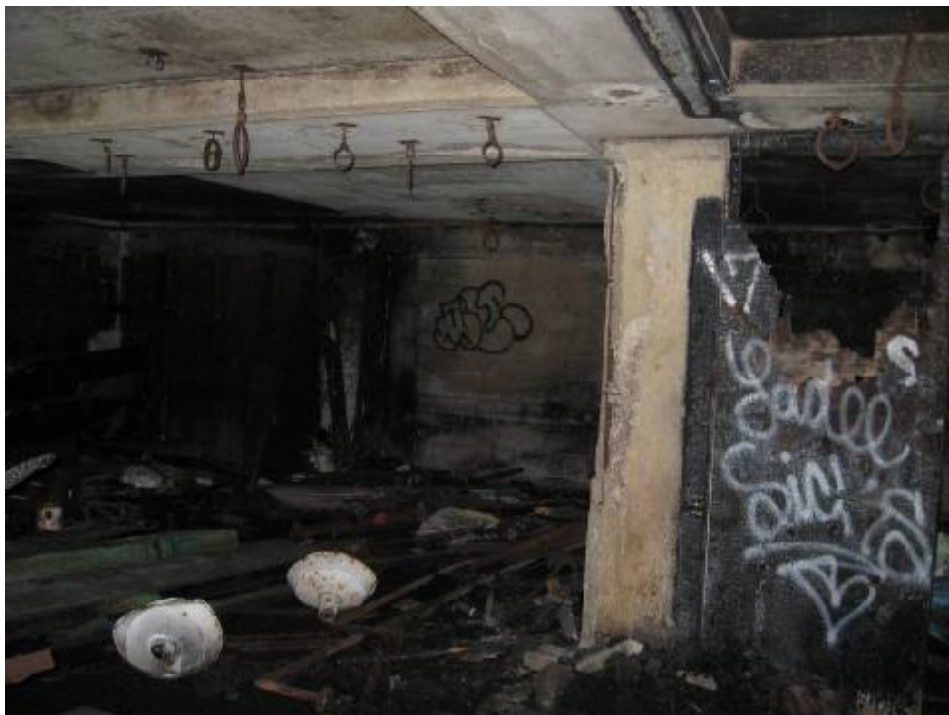
Photo 18

There appears to have been a fire on ground level in the room between grid lines 2 and 4 which may have caused the damage to the mezzanine slab above and adjacent columns. Columns C-3 and D-3 have mild deterioration which may have been caused by a fire and then subsequent corrosion require repair (Photo 18, 19, 20).

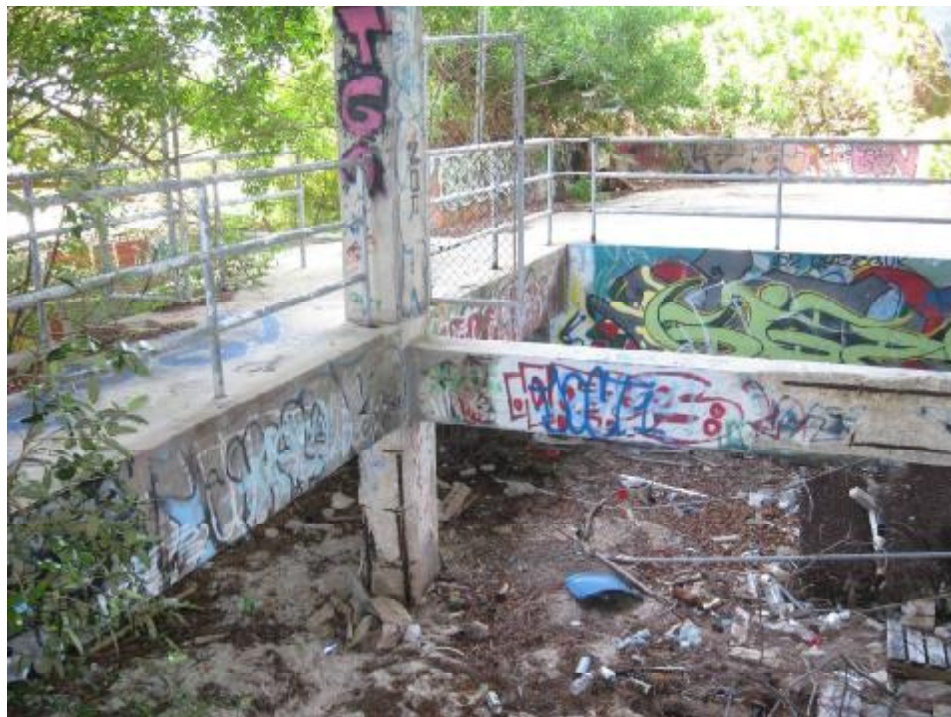
Photo 22

The line of beams supporting the elevated corridor slab on grid line E have severe deterioration and require replacement. There is severe deterioration in the horizontal beam that is directly below the lower seating raker beam on each numbered grid line which requires replacement. The beams on grid lines 1, 17, C and D in the open areas on the east and west ends of the stadium require replacement due to the severe deterioration (Photo 22, 23, 36).

Columns C-1 and C-17 have severe deterioration where 50% of the column cross section has spalled away. There is severe deterioration in columns D-1 and D-17 which require replacement of the column (Photo 22, 23, 38, 40, 47).

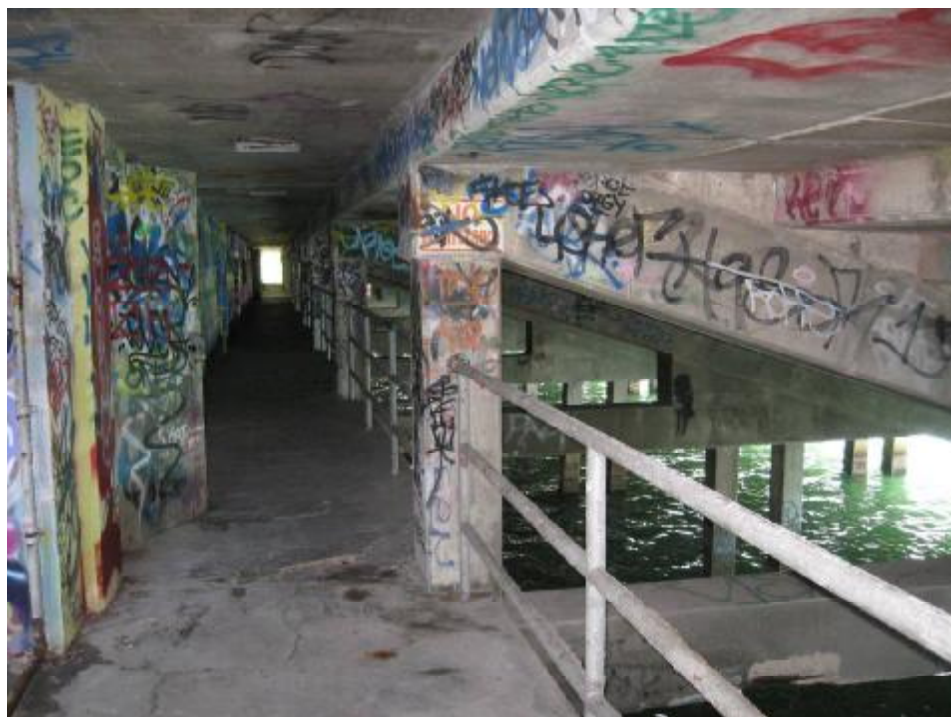
Photo 24

The elevated slab for the corridor between grid lines D and E that runs the full length of the stadium below the lower seating has severe deterioration and requires replacement (Photo 24, 25, 26, 28, 43, 44).

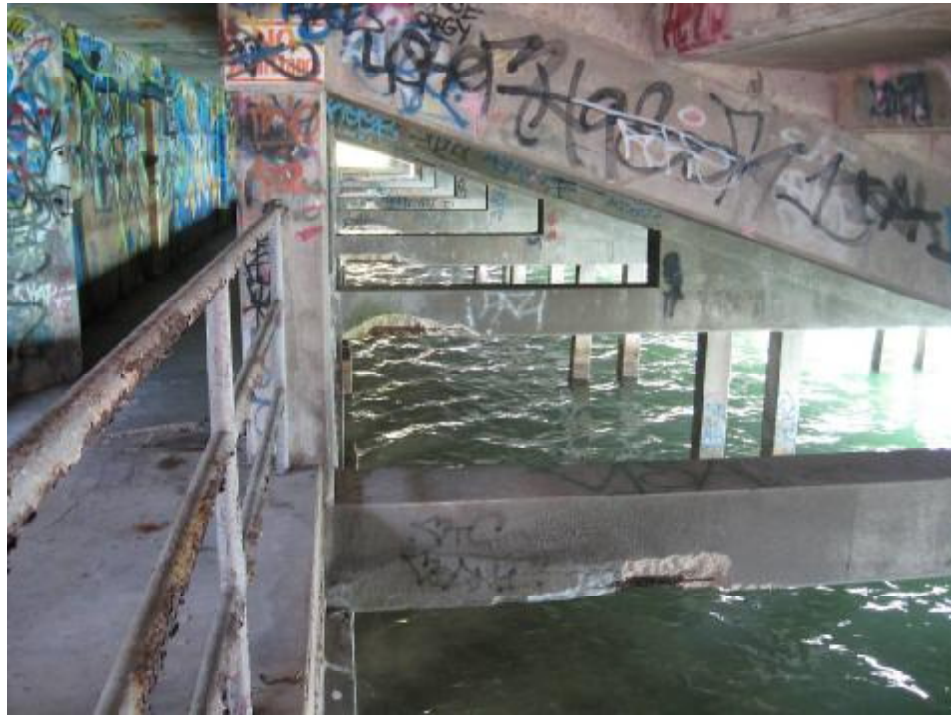
Photo 27

The corrosion is so severe at most of the beams described above that 50% or more of the beam's cross section has spalled away and is missing, and very little is left of the beam's reinforcing steel cross sectional area (Photo 27, 29, 30, 32, 33, 36, 43, 44, 45, 46, 48, 49).

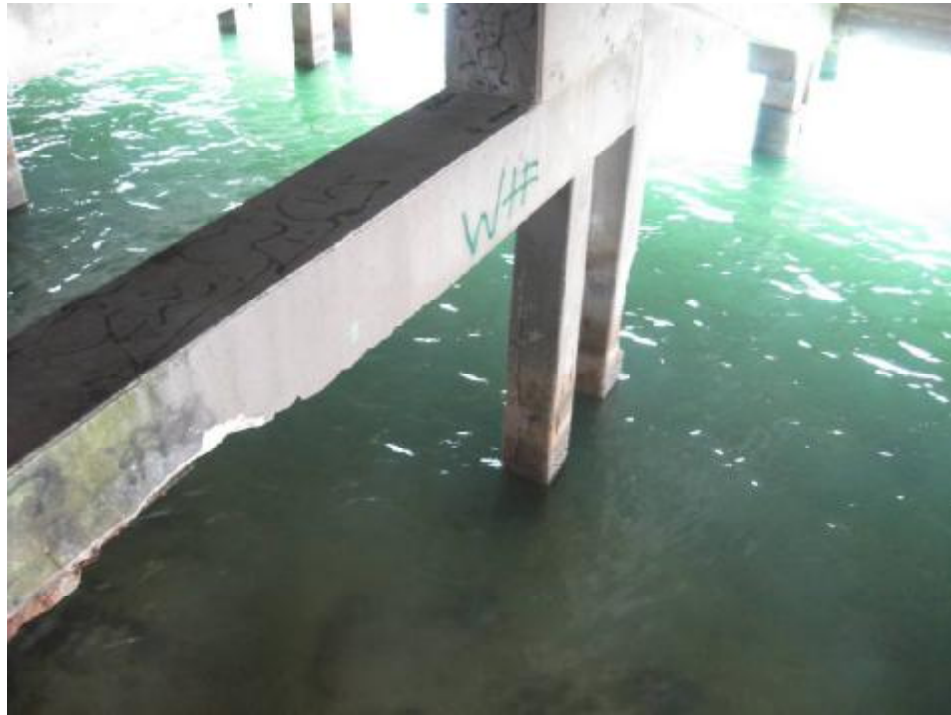
Photo 32

Approximately 40% of the piles supporting the lower bleacher seating area require repair. Their conditions range from piles that have vertical cracks which are consistent with the presence of corroding rebar in the pile, to a number of piles where the corrosion damage has caused 50% of the pile cross section to break away (Photo 32, 33, 34, 35, 42). There is one pile that is totally missing on grid line 2.

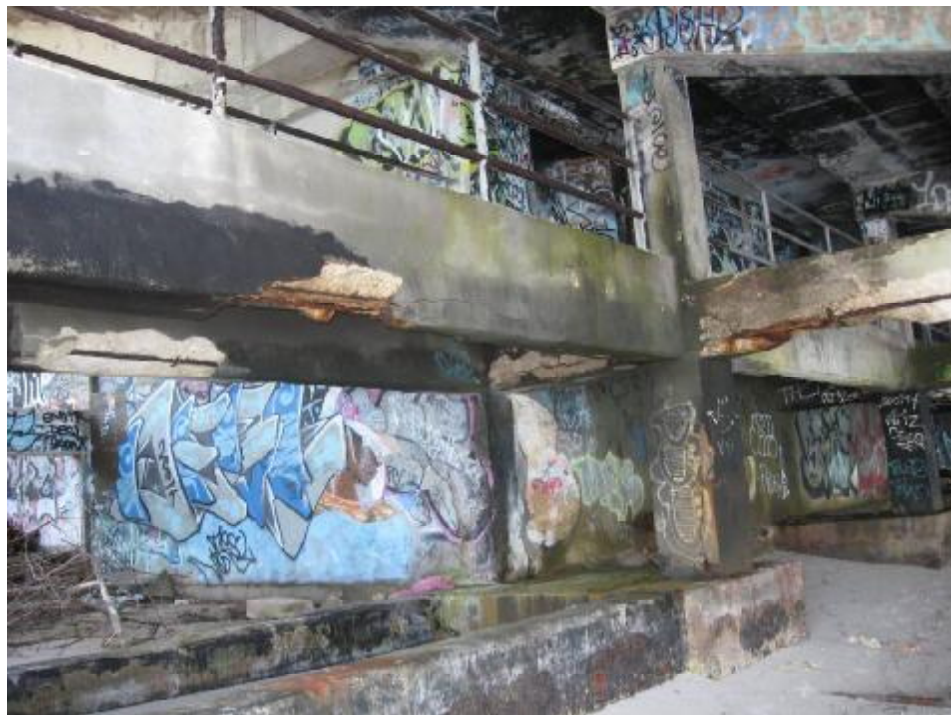
Photo 35

The beam on grid line J is moderately deteriorated with corroding rebar and spalling concrete requiring repair and 30% replacement (Photo 35).

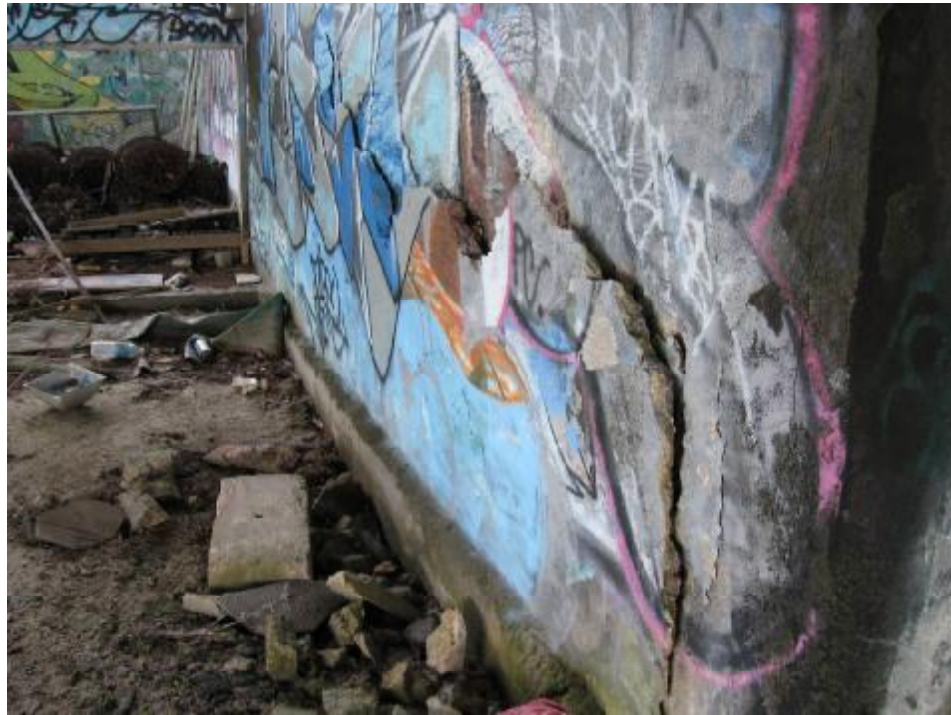
Photo 36

The columns on grid line E supporting the corridor slab and the lower seating raker beams are severely deteriorated and require replacement (Photo 36, 39, 41, 43, 47). Many of the columns appeared to have been previously repaired, however, there are cracked and spalled portions of the column that are nearly 8" deep into the column.

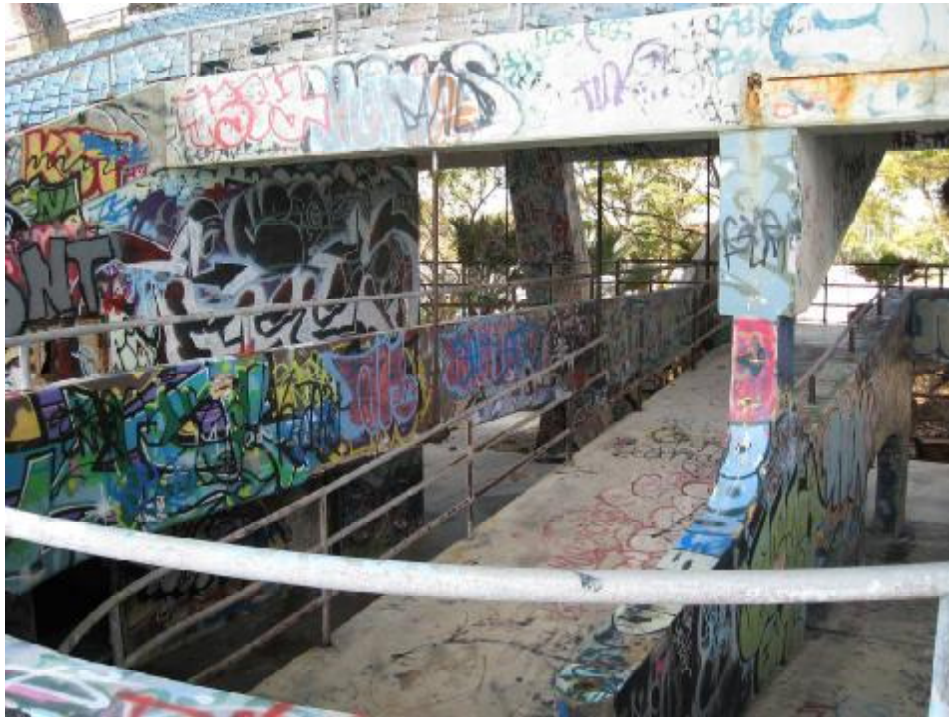
Photo 50

ends of the stadium on grid lines 1, 2, 16 and 17, and on grids C and D. All of these columns require repair (Photo 50).

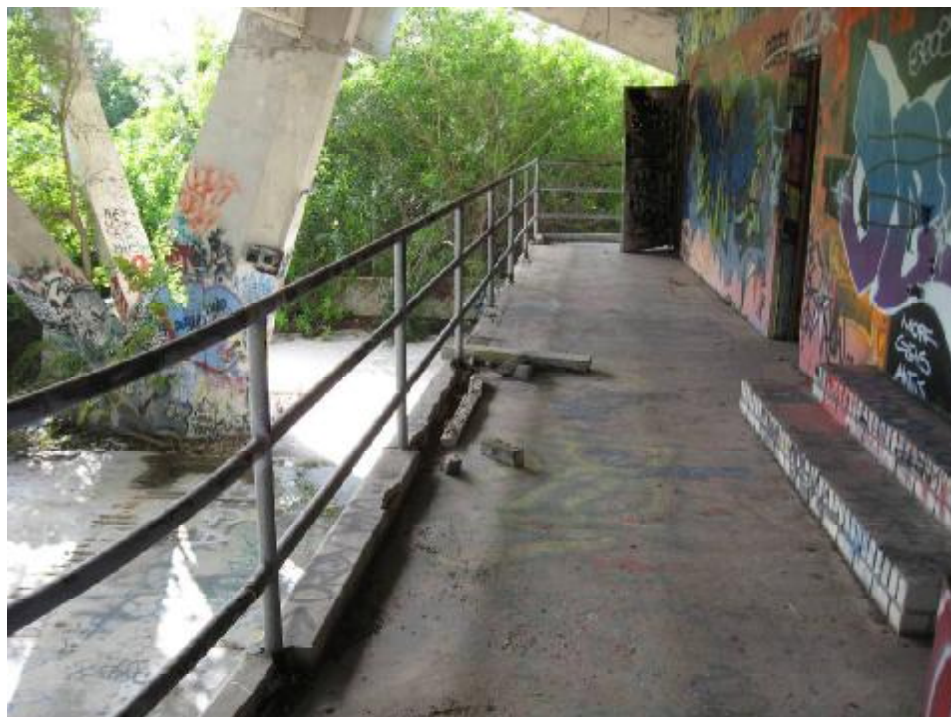
Photo 55

All of the curbs at the slab edge in which the railings are anchored to are severely damaged from corroded railings and rebar (Photo 55, 56, 58, 59). In many areas the curb has broken apart and fallen to the ground level below. All of the curbs require replacement. The slab edges also require repair.

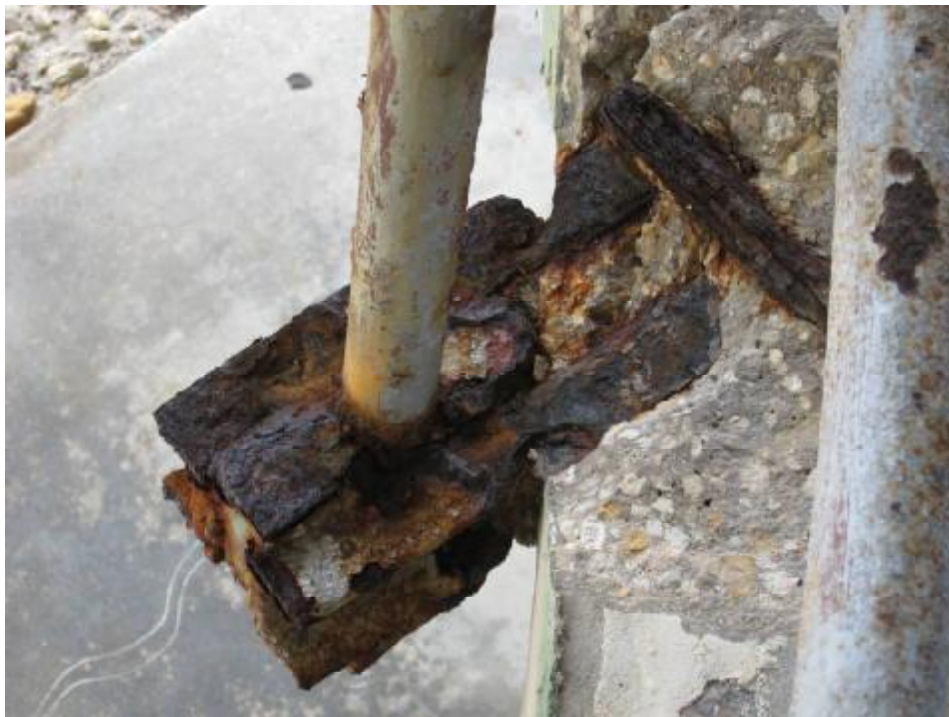
Photo 59

All of the hanger rod connections to the slab are severely corroded and require replacement (Photo 59, 60, 61). At some locations there is very little remaining of the embed that the hanger rod bolts to, and as precaution to prevent failure it's recommended that the slab edge be shored immediately. The repair may consist of installing new columns below to support the slab edges which are supported on new grade beams.

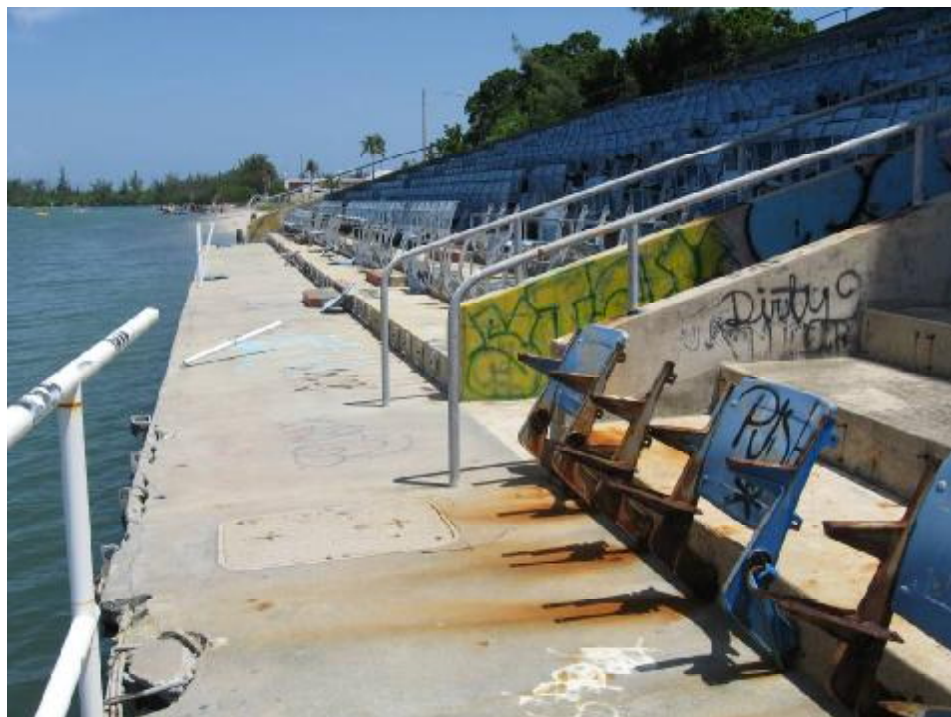
Photo 65

The lower walkway along the water has many cracks that run both across the width and along the length of the slab. The crack widths range from 0.013" to 0.025". At many locations the slab is damaged with missing portions of the slab and exposed rebar (Photo 65, 66, 67). It appears that the slab edge may have been struck, causing the damage. At other areas along the slab edge there is spalled concrete and exposed corroded rebar.

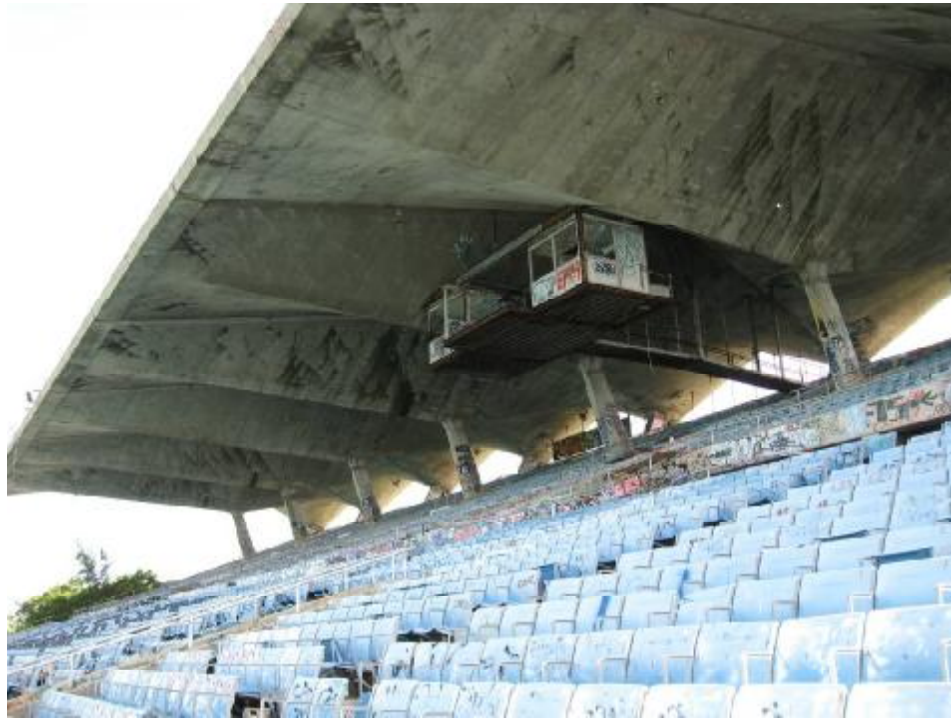
Photo 68

All of the hand railings are severely corroded at the base, and many are broken away from the structure (Photo 68). All railings require replacement.

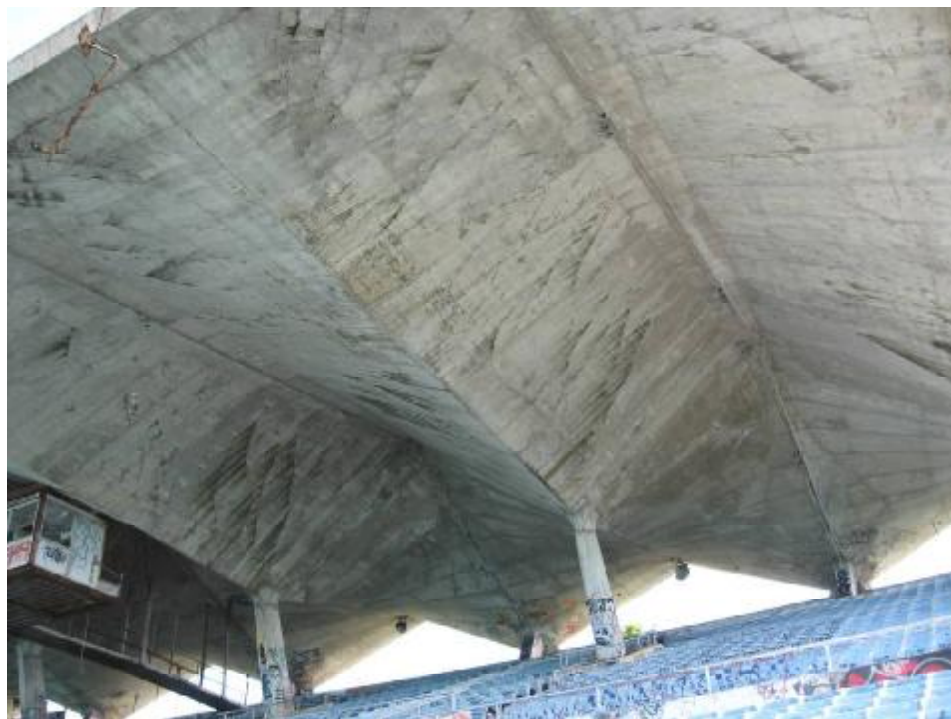
Photo 69

There is extensive cracking in the cantilevered portion of the roof structure. There is diagonal cracking in each web of the V-shaped cantilever (Photo 69, 70, 71, 72,

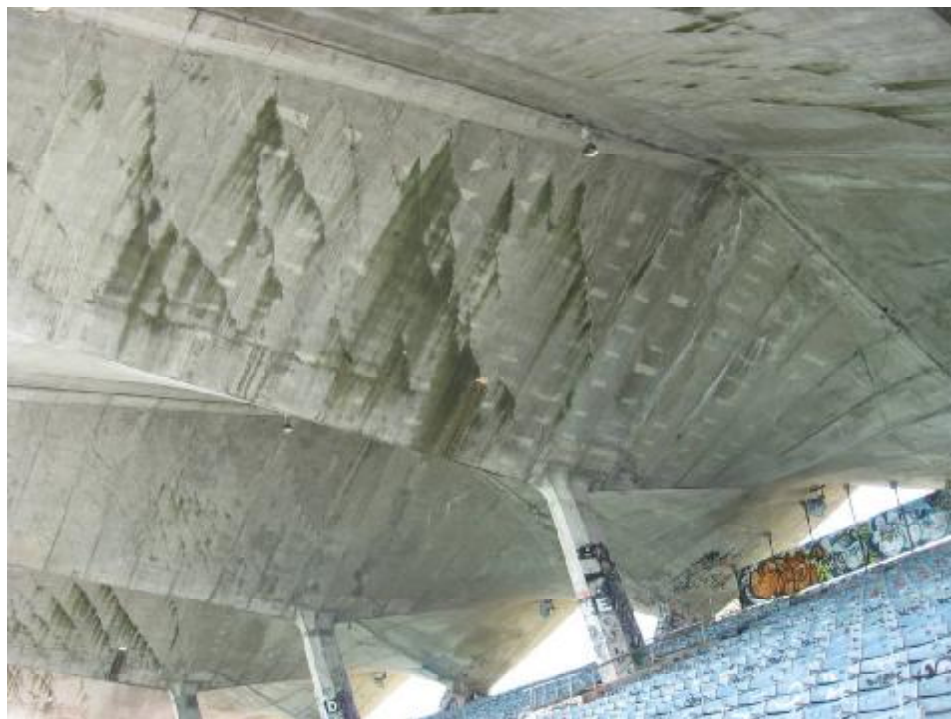
Photo 71

There are indications that water has been leaking through the cracks because of the staining on the underside of the roof slab. The staining consists of dark stains (Photo 71, 72, 73, 75, 76, 78, 79, 80, 84) and white efflorescence (Photo 72, 84, 85, 86, 87, 89). In many locations the white efflorescence is built up, forming stalactite-shaped deposits hanging from the underside of the roof slab (Photo 85). The locations of the dark staining seem to correlate with the locations where the roof drains are inoperable and there is dark colored standing water. The dark water color appears to be the result of the sediment and debris that has accumulated in the valleys.

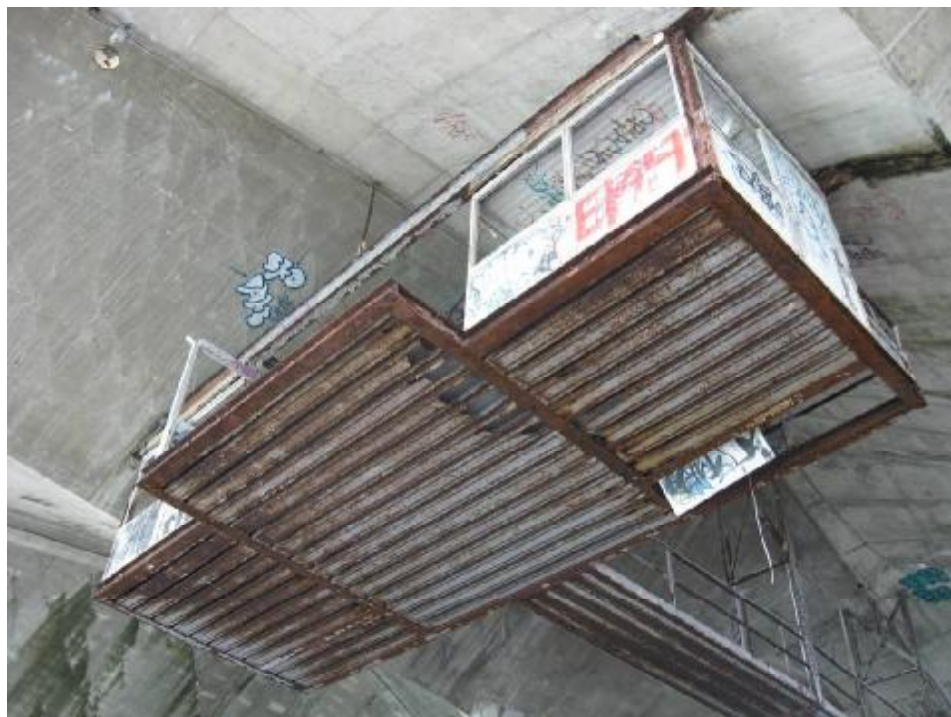
Photo 73

73, 75, 76, 77, 78, 79, 80, 81, 84, 86, 87). The diagonal cracking originates from approximately 2 to 3 feet above the bottom of the valley and extends to the top of the ridge. At the point where the cracks start at the valley there is a horizontal crack that runs parallel to the valley for the length of the cantilever (Photo 72, 75, 78, 79, 89). The cracking is visible from both the underside and topside the roof slab. Crack widths in the topside of the roof slab were 0.040" wide, with some wider cracks. The diagonal cracks are spaced between 2 to 3 feet on center and in many cases the spacing is smaller, with smaller cracks branching off the larger ones. Illustrations of the typical cracking pattern are shown on pages 31 and 32.

The structural steel that frames the press box structure which is hung from the roof structure is severely corroded and unsafe (Photo 73, 74, 82, 83). All of this structure needs to be replaced.

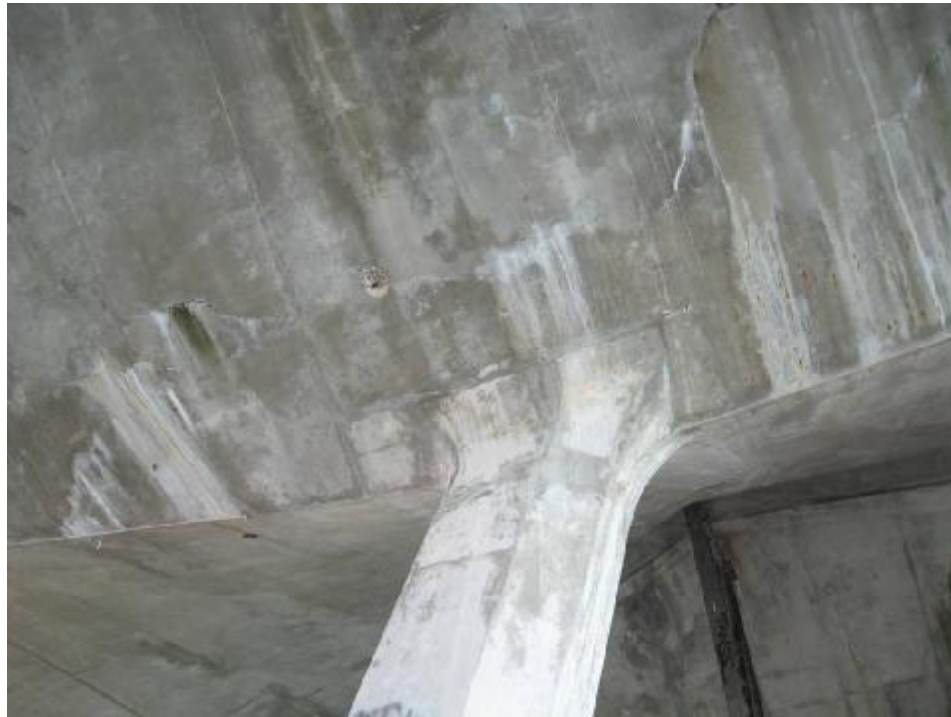
Photo 88

There is a crack in the pour strip located at the ridge of the V-shaped roof running parallel to the ridge (Photo 88, 113).

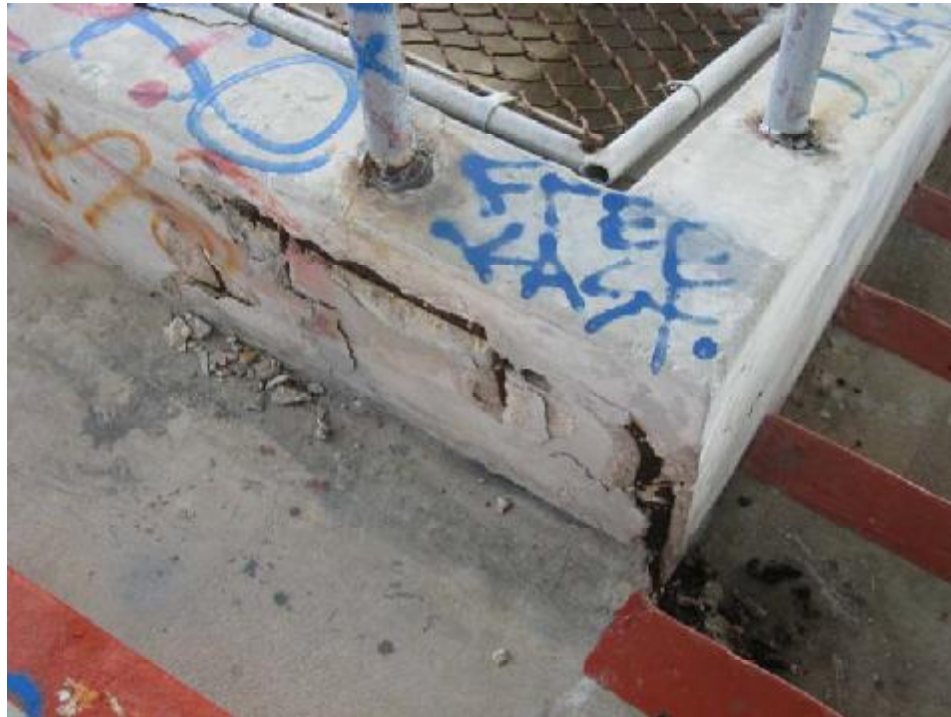
Photo 90

The concrete walls around the bleacher openings for the main roof columns are severely deteriorated and required 30% replacement (Photo 90, 91).

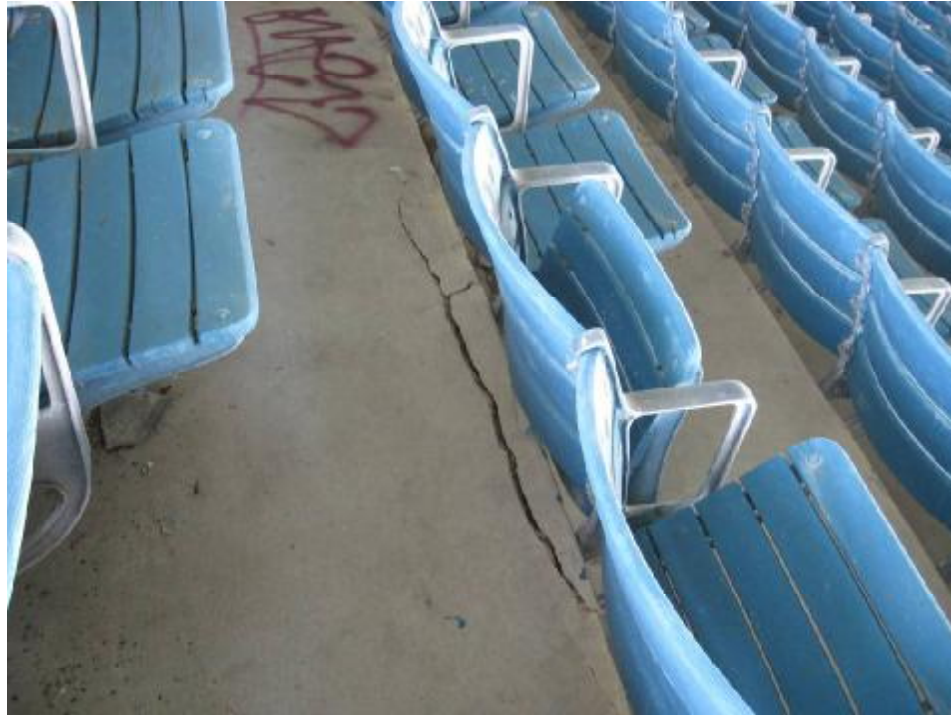
Photo 92

The upper 41" wide row has moderate deterioration with many areas of spalled concrete and exposed, corroded rebar (Photo 92).

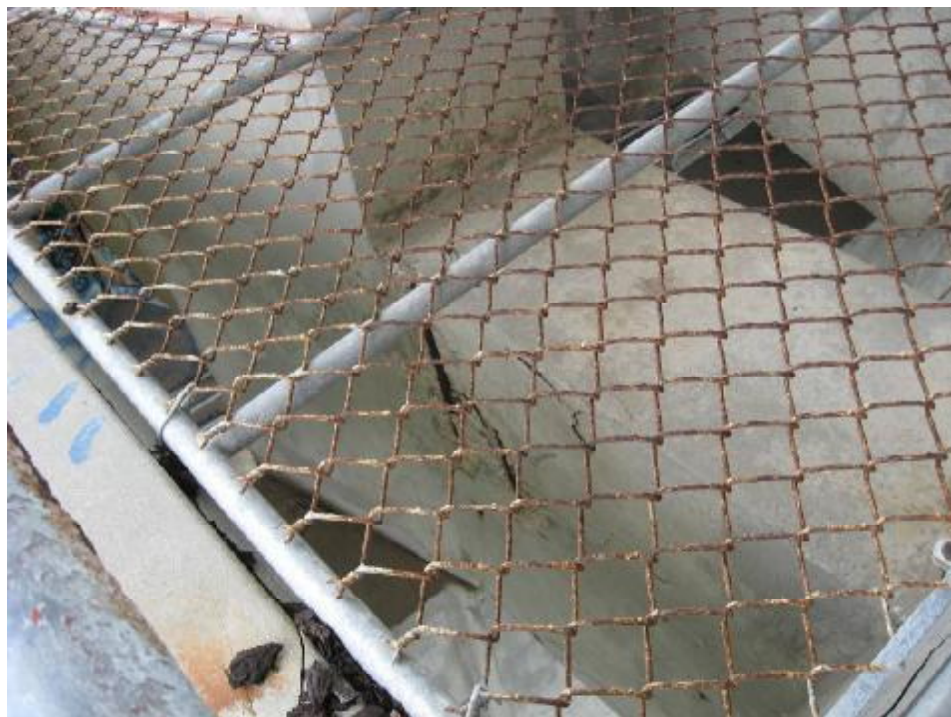
Photo 93

The bleachers have mild deterioration with many areas of spalled concrete and exposed corroded rebar along the edge of the bleacher step (Photo 93).

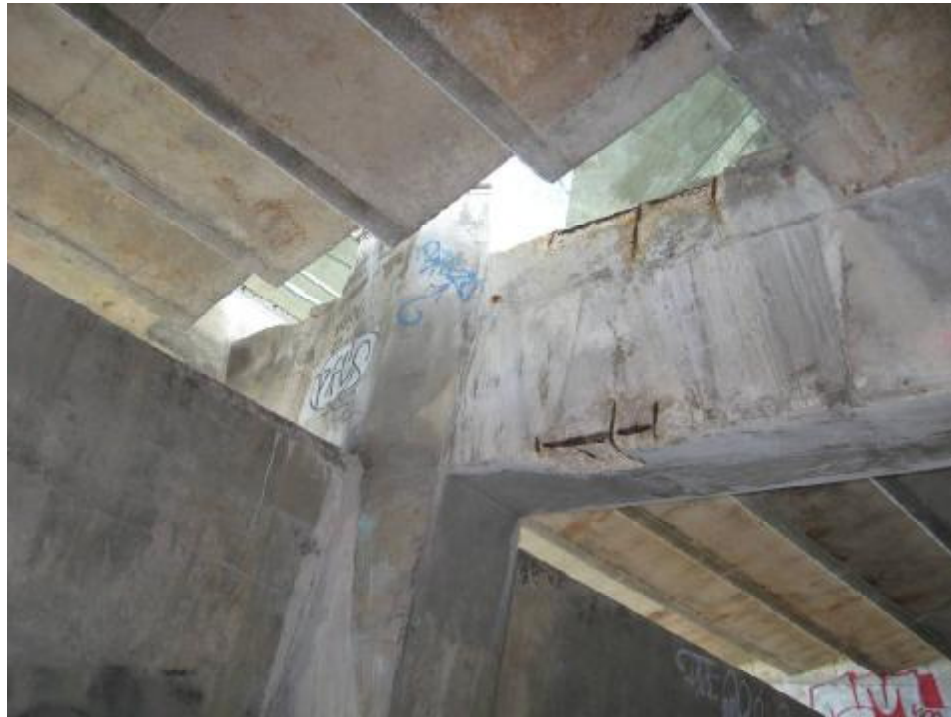
Photo 94

There was no visible deterioration observed in the raker beams at this level, except where the bleachers are open around the main roof columns. In these locations at the beam-to-column joint there is moderate deterioration in the beams (Photo 94, 95).

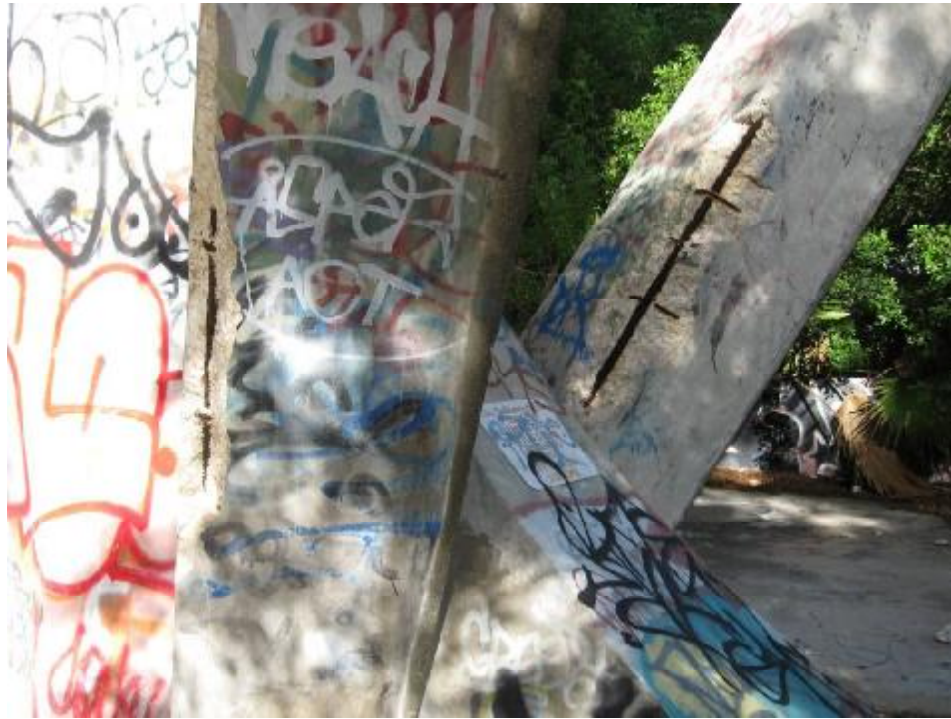
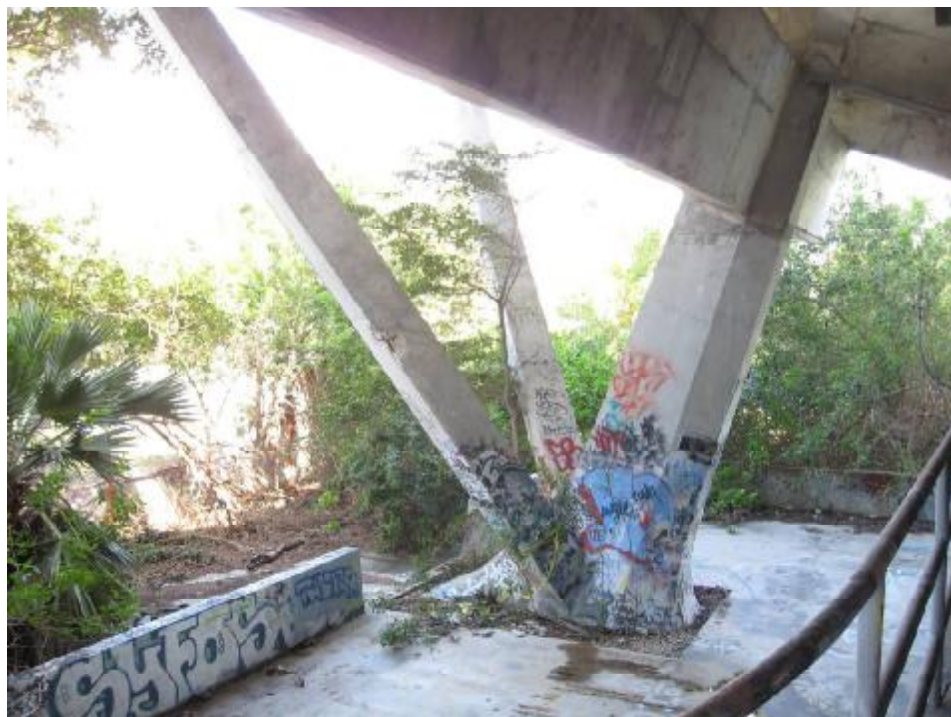
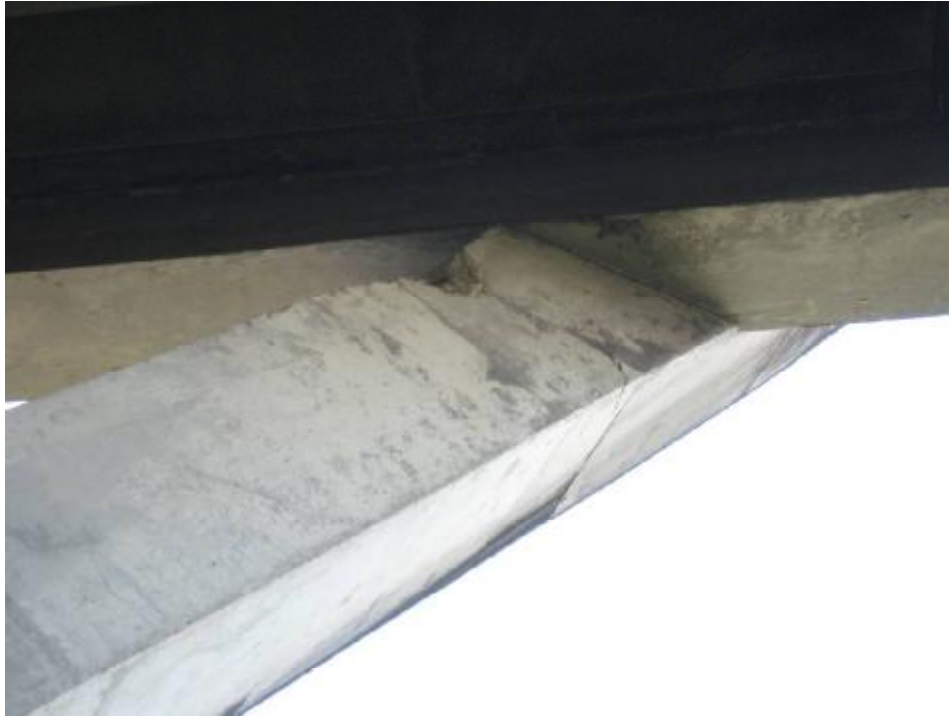
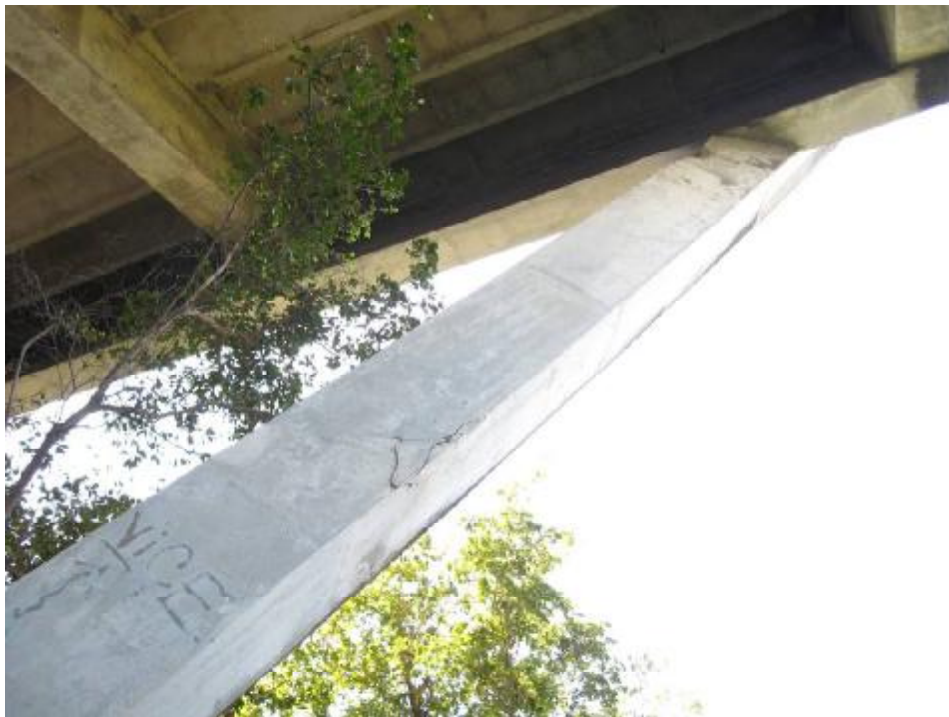
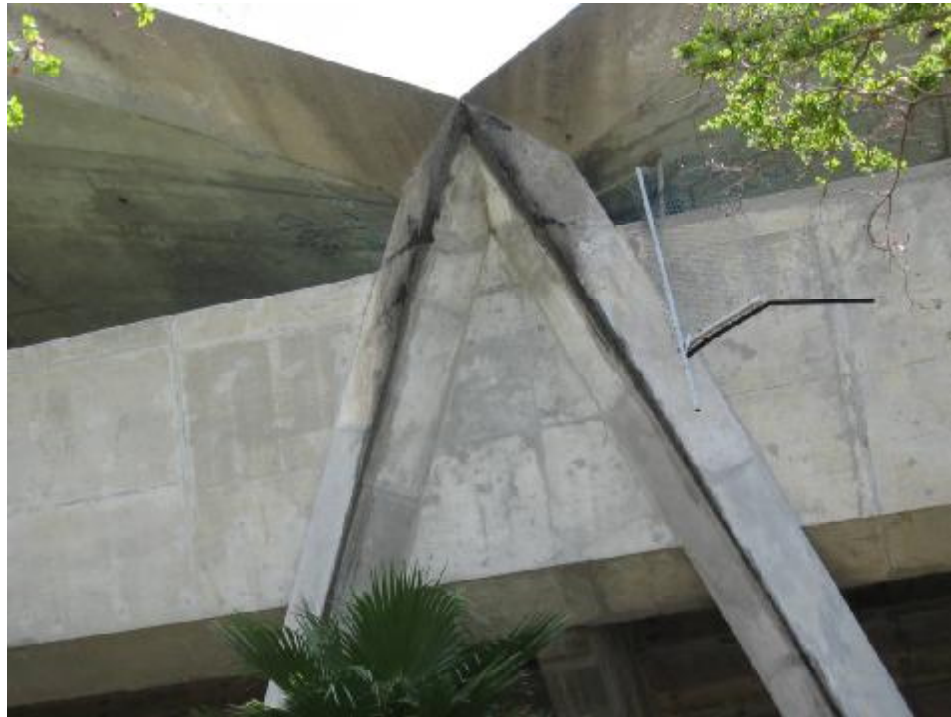
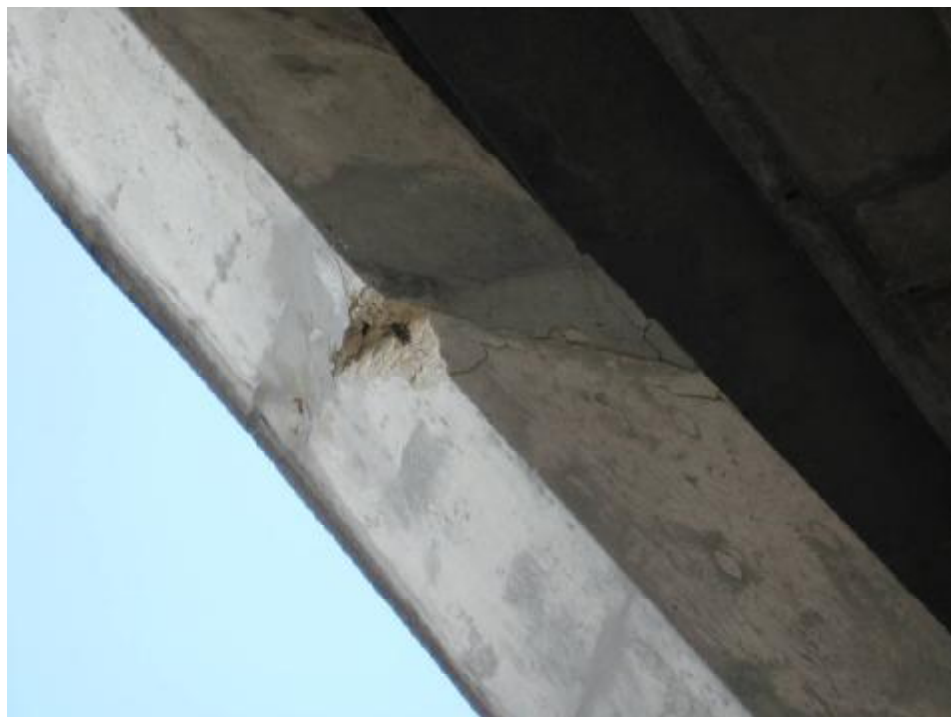
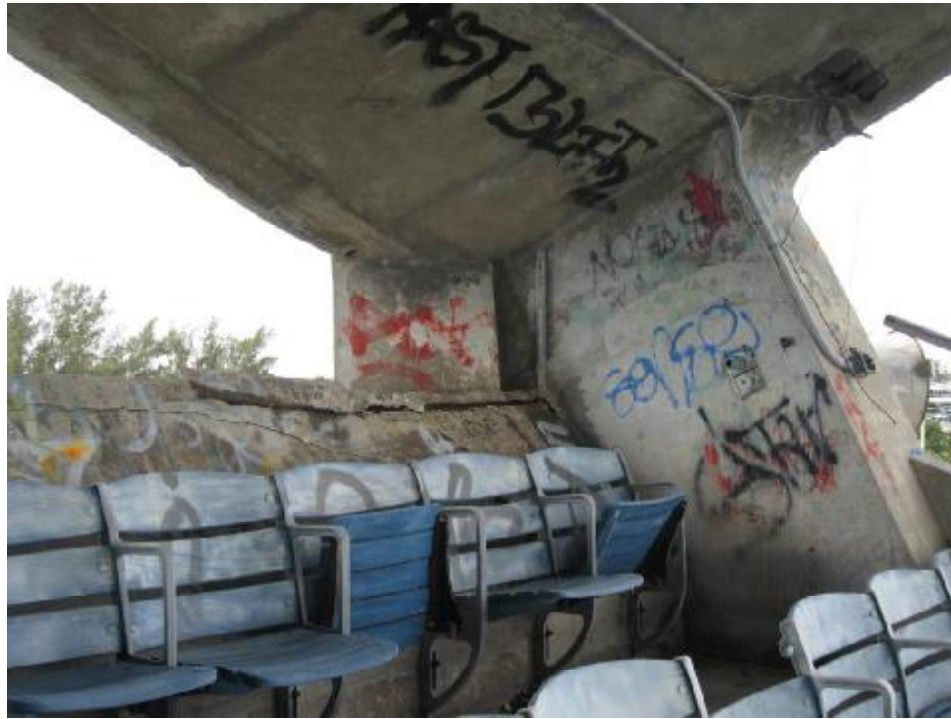
The diagonal tension columns have moderate deterioration. There are 50% of the columns requiring repair due to corroding rebar and spalling concrete (Photo 96, 97, 98, 99, 100, 101, 102). There are cracks across the cross sections that are 0.025" in width.

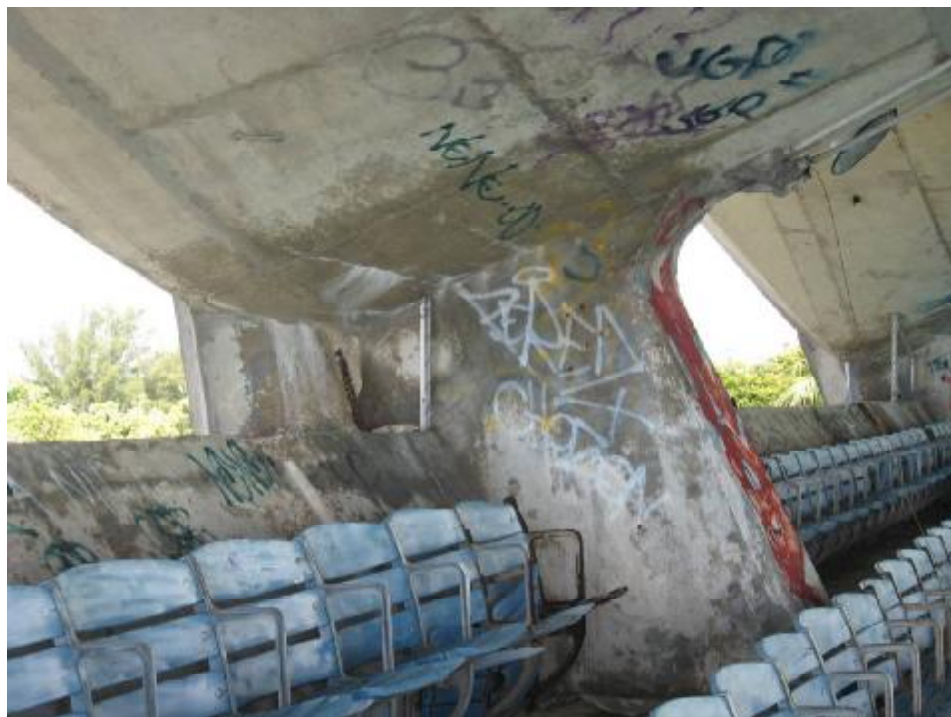
Photo 103

The uppermost beam supporting the bleachers and the raker beams on the even grid lines has severe deterioration in the upper portion of the beam (Photo 103).
